WELL #6 GST

**Comprehensive Inspection
For
The City of Pflugerville**

500,000-gallon Ground Storage Tank
July 2020

PROJECT REPORT

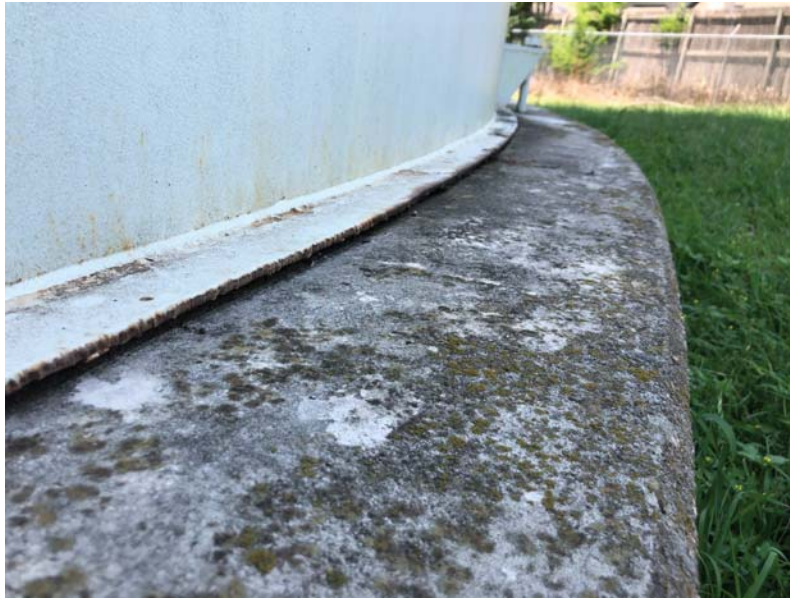
A. **Foundation:** The tank foundation consists of a concrete ring beam. The majority of the foundation appeared to be in good overall condition with small width cracking in several locations. The floor extension plate to ring beam foundation has no protection along the edge and has failed to seal the interface. *See photos below.*

1. Make any necessary interior/exterior welding repair, corrosion related repairs and general repairs to the tank and foundation. This includes: Repairing concrete foundation cracks and voids by cleaning and filling cracks with flexible concrete patching mortar. Repairing any holes in the floor and shell after initial interior abrasive blasting that unveils any metal loss or pitting by weld overlay, applying 100% solids epoxy surfacing compound. Grinding all sharp edges, weld splatter, arc strikes, uneven weld profiles, and any other defects that do not provide adequate anchor profile and causes a lack of coating adhesion. The resident inspector and engineer should identify any repairs necessary. All welding conducted on this project is to be conducted by a welder certified to ASME Section IX or AWS D1.1 (tests as described in AWS B2.1) code shall conduct all welding on this tank.

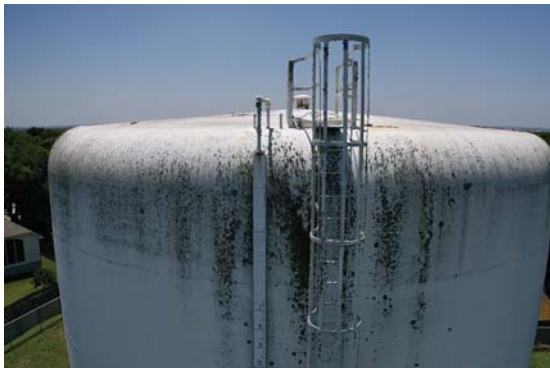
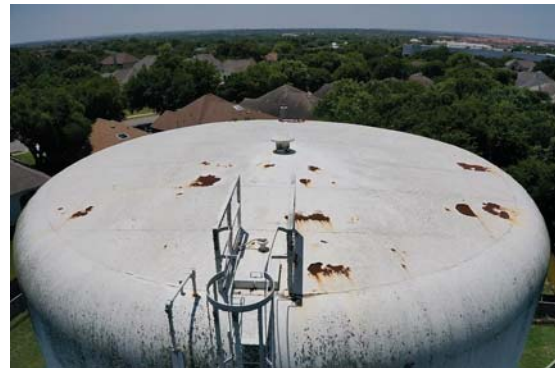
2.1 Exterior Surfaces – The existing coating system is not known but is assumed to be an epoxy/urethane coating from the original construction. The coating is exhibiting moderate rust rash corrosion, coating delamination and chalking along the shell and on top of the roof as seen in the attached photos. The integrity of the exterior coating is aged and is in fair condition at the areas accessed during the inspection. The adhesion is less than acceptable for spot repairs and an effective overcoat application, therefore a complete coating removal should be considered before placing tank back into service.

B. **Exterior Coating Condition:** The exterior coating system on the shell and roof is in poor condition. The shell protective coating has oxidized and chalked from the UV sunlight and weather. There is mildew and growth spores covering much of the knuckle with the roof exhibiting total coating failure as seen in the photos. Brittleness, cracking and top coat delamination was observed at areas, indicating that the coating has reached its overall protective life. *TCEQ Rule 290.43 (c) (8) requires coatings be maintained in strict accordance with current AWWA Standards. See photos below.*

4. Install an AWWA approved 30" Ø shell manway with a davit arm.
5. Apply an industrial coating system using trained and qualified coating applicators. The Tnemec Coating System is recommended utilizing the coatings available from Tnemec. Clean the exterior surfaces to a SSPC-SP 6, Commercial Blast Cleaning and apply a Zinc/Epoxy/Urethane system. Clean the interior surfaces to a SSPC-SP 10, Near White Blast Cleaning and apply a Zinc/2-Coat Epoxy system. ***(A detailed coating specification shall be written under a separate cover upon review and discussion of this report. The system above may be changed depending on the existing coating system results and the time of year the tank will be rehabilitated).***

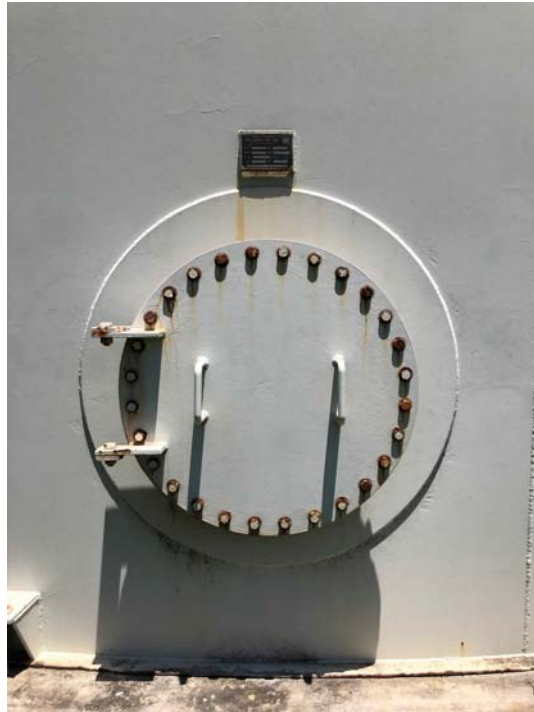
C. **Shell Manway:** The shell 24"Ø manway has a flanged bolted plate cover on a hinge with a reinforcing pad around the tank shell penetration. The cover is with gasket and leak tight showing signs of deterioration and corrosion on the bolts. *TCEQ Rule 290.43 (c) (10) requires a 30"Ø access in the lower ring of a GST. See photo below.*

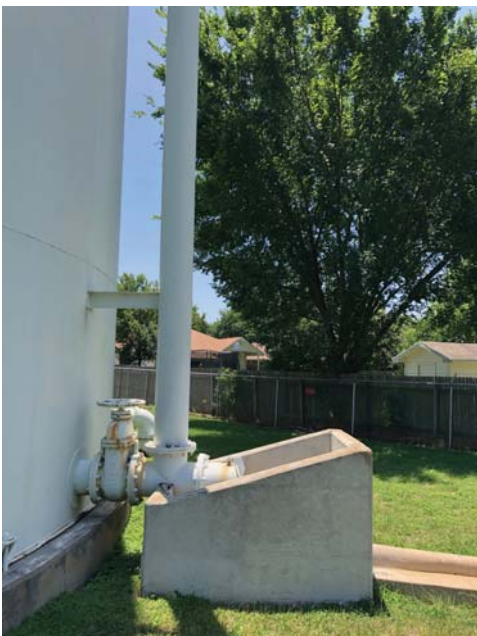
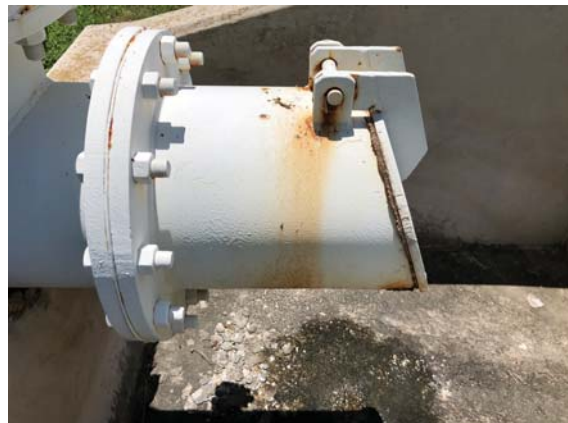
D. **Overflow Pipe:** The 12"Ø overflow pipe exits through the top of the shell ring and extends straight down the shell and exits out above the tank perimeter foundation which it discharges through a plate flap closure 26" above the splash vault. The gap between the pipe and plate flap closure has been reduced with a silicone caulking that is considered a temporary adjustment. *TCEQ Rule 290.43 (c) (3) requires all covers fit tightly with no gap over 1/16". See photo below.*

3. Remove the existing 12" Ø overflow plate flap closure and install a new clow flap valve closure. A bolt on flange type or weld on is acceptable. Maintain all air gap dimensions from current ground level.

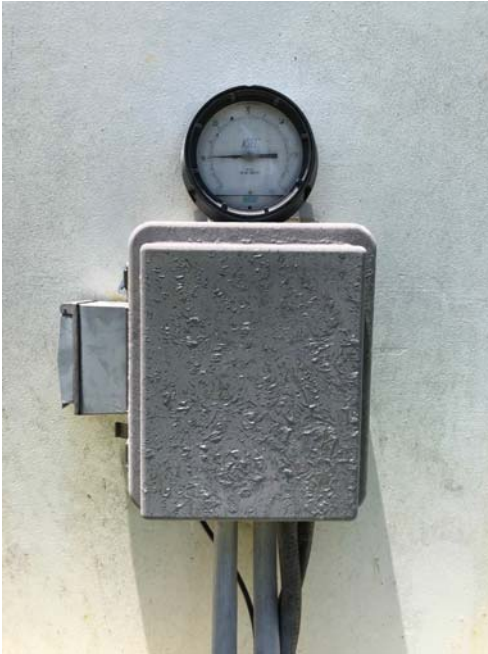
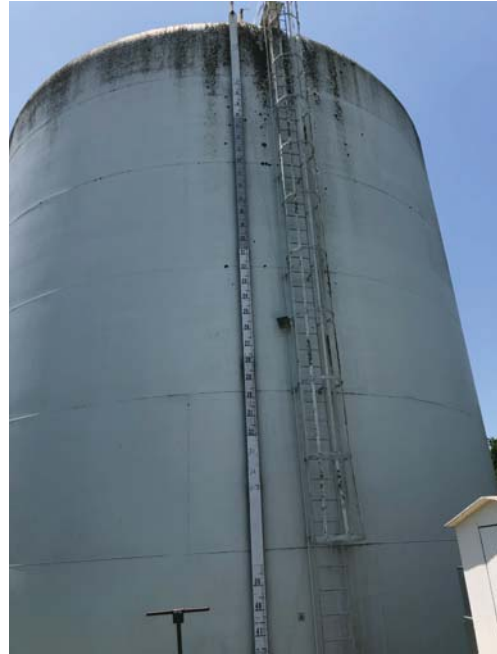
E. Water Level Indicator: The tank is fitted with a floating target gauge with level increments on the target and a pressure foot gauge. The level gauge and pressure gauge are not operable. *TCEQ Rule 290.43 (c) (4) that states all tanks have a level indicator at the tank site. See Photos below.*

- The water level indicator is not functioning. *TCEQ Rule 290.43 (c) (4) that states all tanks have a level indicator at the tank site.*
- The exterior ladder is not fitted with a safety climb device or a vandal deterrent door and is not *ANSI/OSHA* compliant.
- The roof access hatch is not in compliance. *TCEQ Rule 290.43 (c) (20 requires the primary roof access opening to be 30" diameter*
- The roof vent is not in compliance. *TCEQ 290.43 (c) (1). Require vents to be designed in strict accordance with AWWA Standards.*
- The interior access ladder has deteriorated and is unsafe and compliant with *ANSI/OSHA*.
- The interior roof support system has deteriorated from the corrosion and is unsafe to walk on the roof or place the tank back into service.
- Sediment levels on the floor of the tank exceed the sanitary standards for Potable Water Storage.

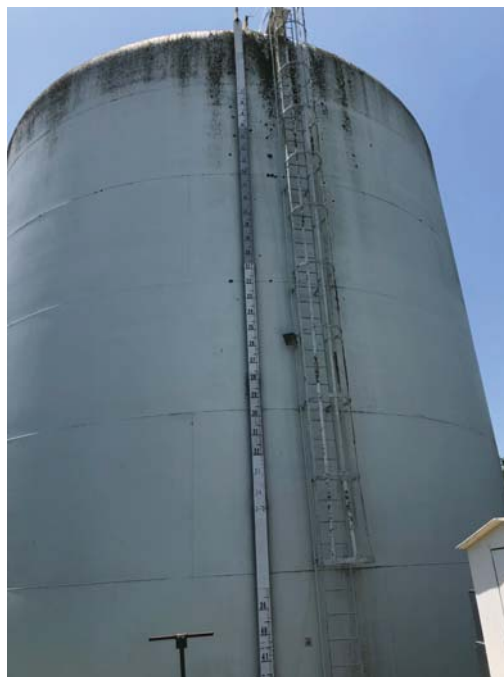
F. Exterior Ladder: The ladder is 16” wide with 3/4”Ø rungs spaced every 12” on center with 10” of standoff for toe room. The ladder is equipped with a cage but no safety climb or vandal deterrent at the bottom of the ladder. The ladder does not meet ANSI/OSHA Standards. *See photo below.*

2. Demo and replace the roof and roof support system with a self-supporting dome roof. The roof will include a new OSHA approved access ladder for the interior and exterior, 24" Ø vent, 30"x30" roof hatch, flanged roof nozzles and overflow weir box. The contractor shall field verify measurements, access to the tank site and design the roof and accessories to AWWA D100. A set of drawings shall be provided and sealed by a P.E. in the State of Texas.

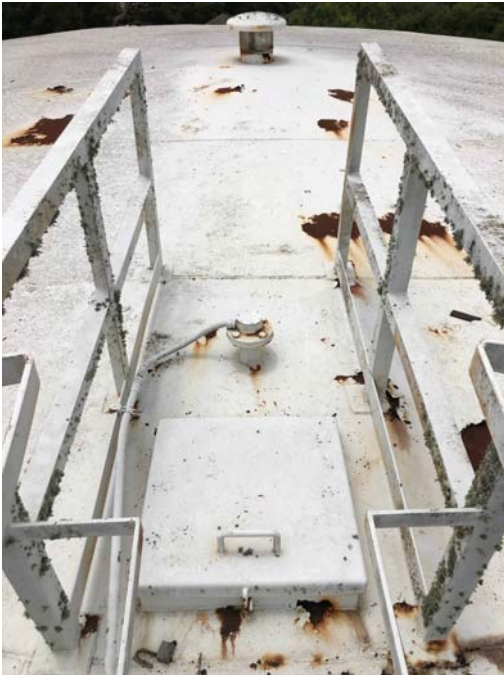
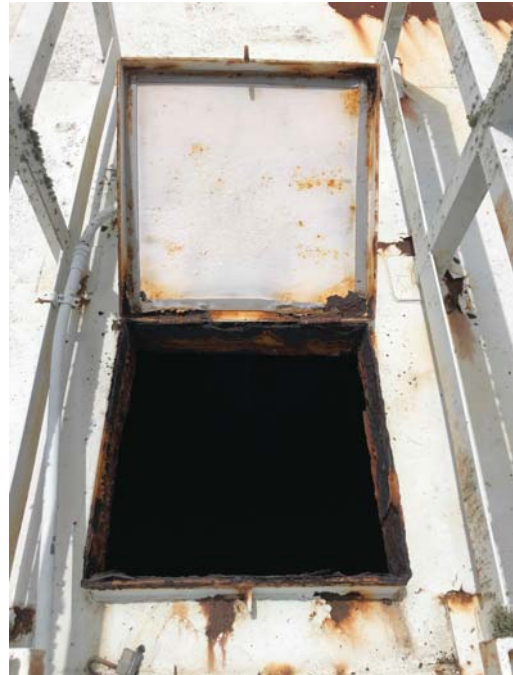
G. Roof Hatch: The roof access hatch is welded steel (24"x24") with a hinged lid and locking hasp with no lock. The hatch neck and hinges are corroded and deteriorated. The access hatch does not have a hold-open device to safely hold the lid open. *TCEQ Rule 290.43 (c) (2) requires the primary roof access opening to be 30" diameter and remain locked. See photos below.*

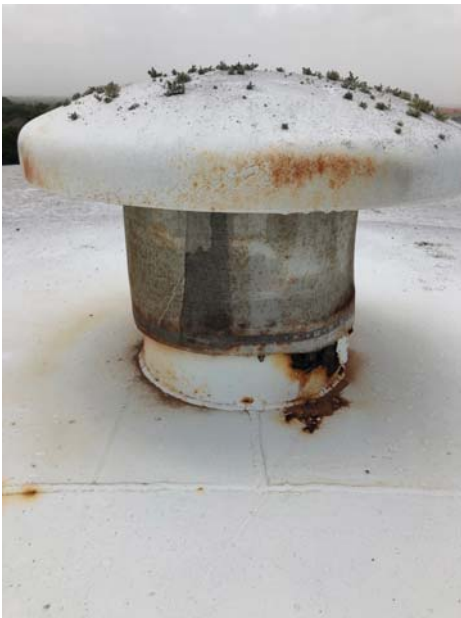
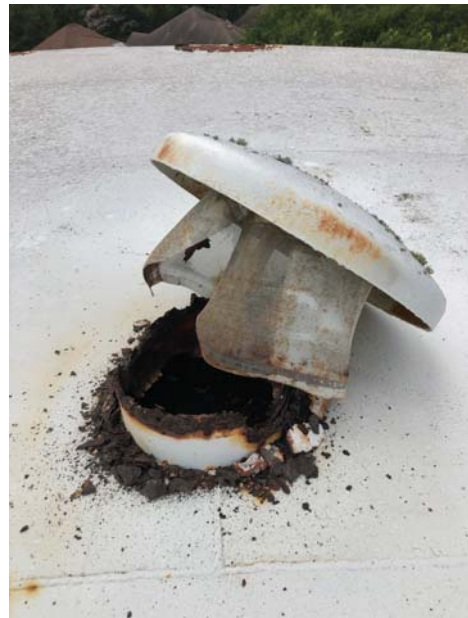
H. Roof Vent: The roof vent is 12"Ø steel construction and welded directly to the roof. The vent has deteriorated and broken from the roof at the neck. *TCEQ Rule 290.43 (c) (1) require vents to be designed and installed in strict accordance with AWWA Standards. See photos below.*

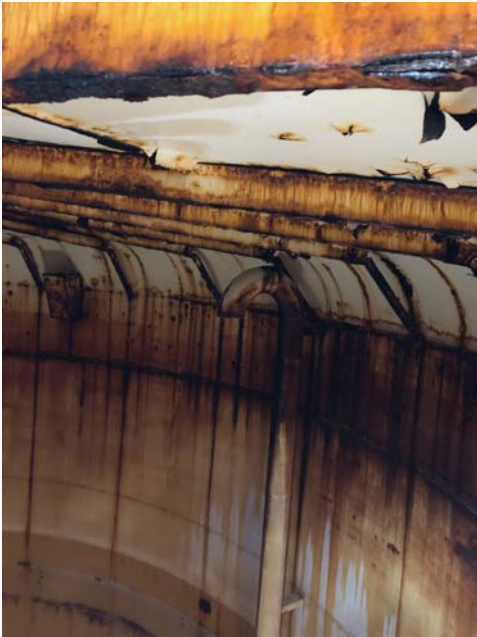
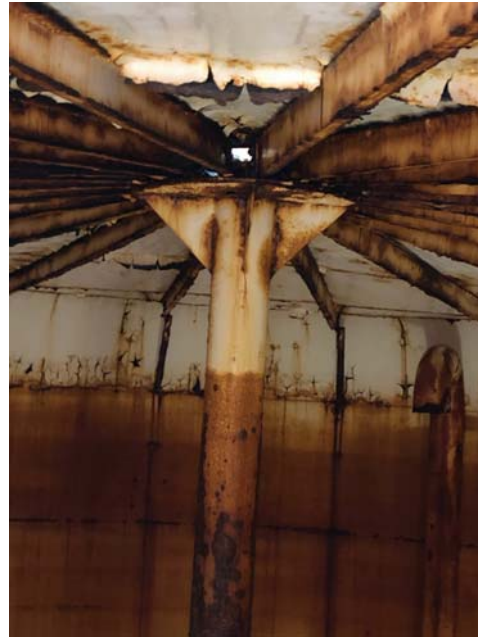
B. **Roof and Support System:** There is severe seam, interface and edge corrosion throughout. The roof is not seal welded together at lap seams or at the top shell angle. Corrosion is actively aggressive and has deteriorated the roof and support system to degree of structural concern for the integrity of the roof. *See photos below.*

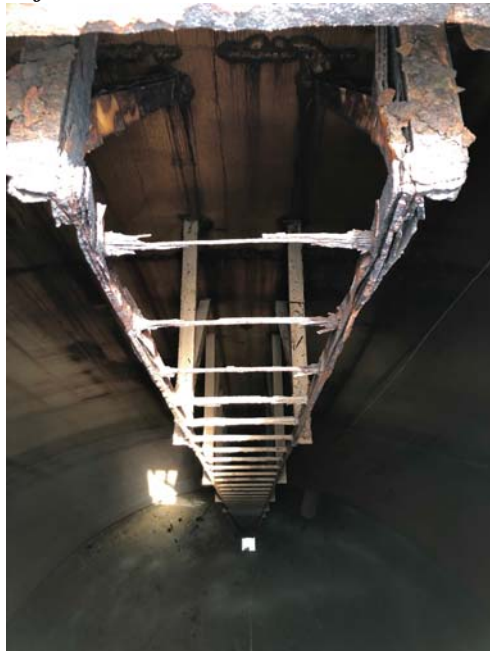
C. **Interior Shell Ladder:** The interior ladder is attached to the shell and is not safe to climb due to the coating failure and total deterioration from the corrosion that has occurred on the interior. *Deficiencies to ANSI/OSHA. See Photo Below:*

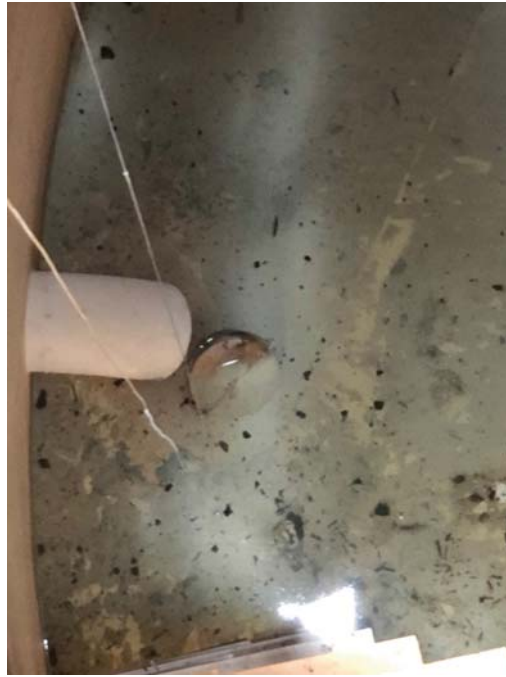
D. Water Level Indicator: The float has been damaged and is broken from the guide cables that operate the float.. *See Photo Below.*

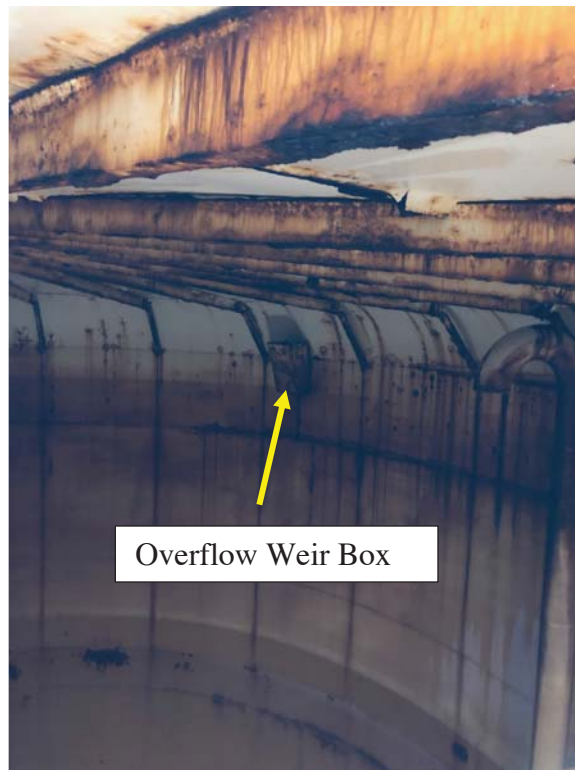
E. Overflow Pipe and Weir Box: The 12"Ø overflow pipe is located on the exterior and enters the top of the shell. The weir box is tapered from the 3' square top opening to approximately 12" at the bottom where it connects to the overflow pipe at the shell. There is excessive corrosion around the top edge and inside of the overflow. and no concerns with the integrity of the weir. *See photo below.*

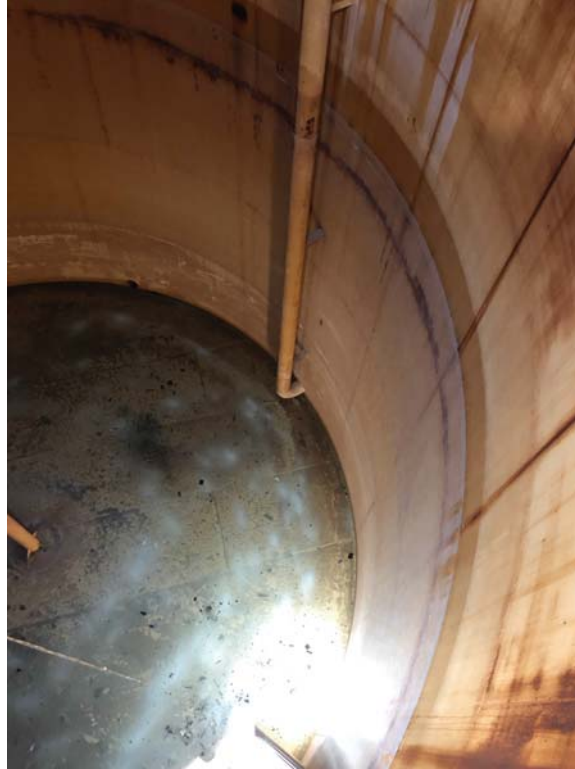
F. Floor and Sediment Level: The coating on the interior floor appeared to be in poor condition with some lap weld seam corrosion. The sediment level depth was undetermined but covered approximately 40% of the floor. *See Photo Below:*
