Re: Construction Cost Analysis for
City of Pflugerville Facilities

CITY OF PFLUGERVILLE

**Facilities – Construction Cost
Analysis**

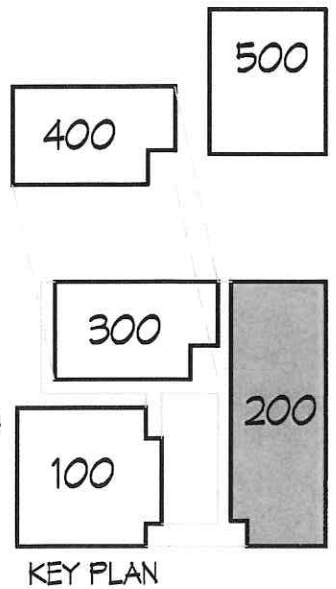
PLAN A.2

ADA Compliance	Front public entrance is compliant. Compliant public restroom located near front entrance. Non-compliant staff restroom in dispatch area of building Non-compliant staff restroom in back area of building Non-compliant break area counter Non-compliant interior doors at several offices as shown on Plan A.2 Non-compliant exterior door at NW corner of building.
Conditions / Characteristics / Crowding	Building is approximately 27 years old, built in 1984. As of January 30, 2008, the appraised value was \$377,000 (See Exhibit 2 AEGIS Group Appraisal). Roof leaks reported and repairs have been performed Crowded inefficient work space Exterior soffit deterioration observed. Roof gutters needed Based on visual observations, the space is generally the poorest occupiable condition on this campus, divided into odd random spaces with the remainder of old jail spaces still visible Currently there are 14 FTE positions from 3 departments –Engineering, Building Official/Inspections, Permits Gross utilization is approximately 214 S.F./FTE

Adjacencies / Efficiencies	Substantial space taken up for filing cabinets Work spaces created from previous build outs do not accommodate staff in equal, efficient space

CITY HALL BLDG 200

CURRENTLY: ENGINEERING & BUILDING INSPECTION

GROSS SF = 3,041

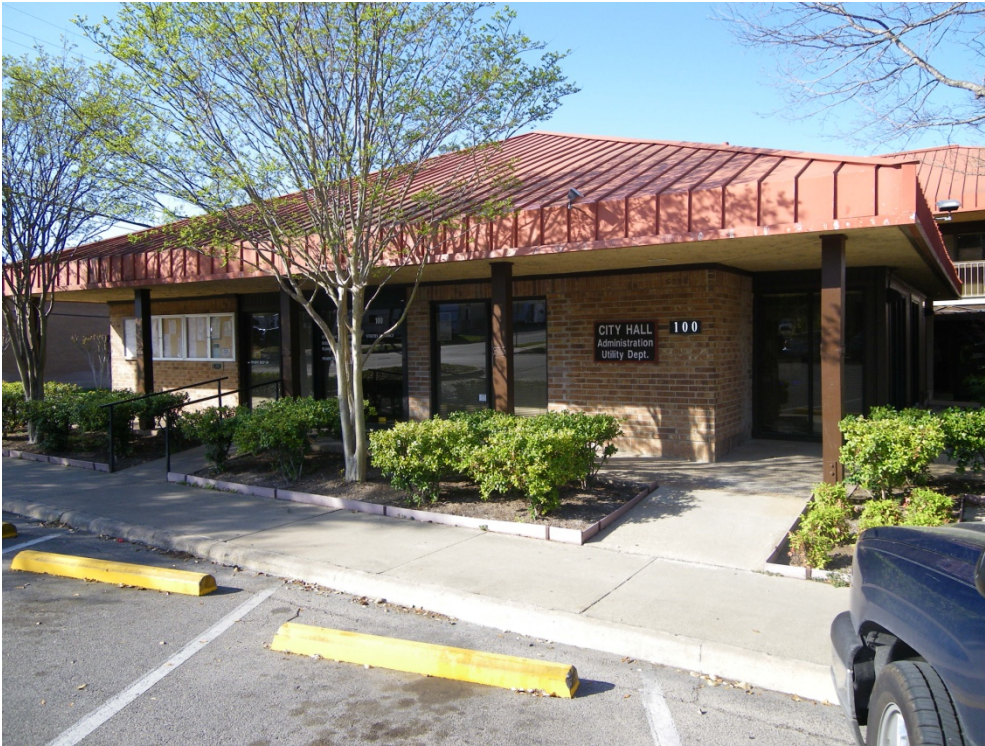
1. Building 100 – Pedestrian pathway

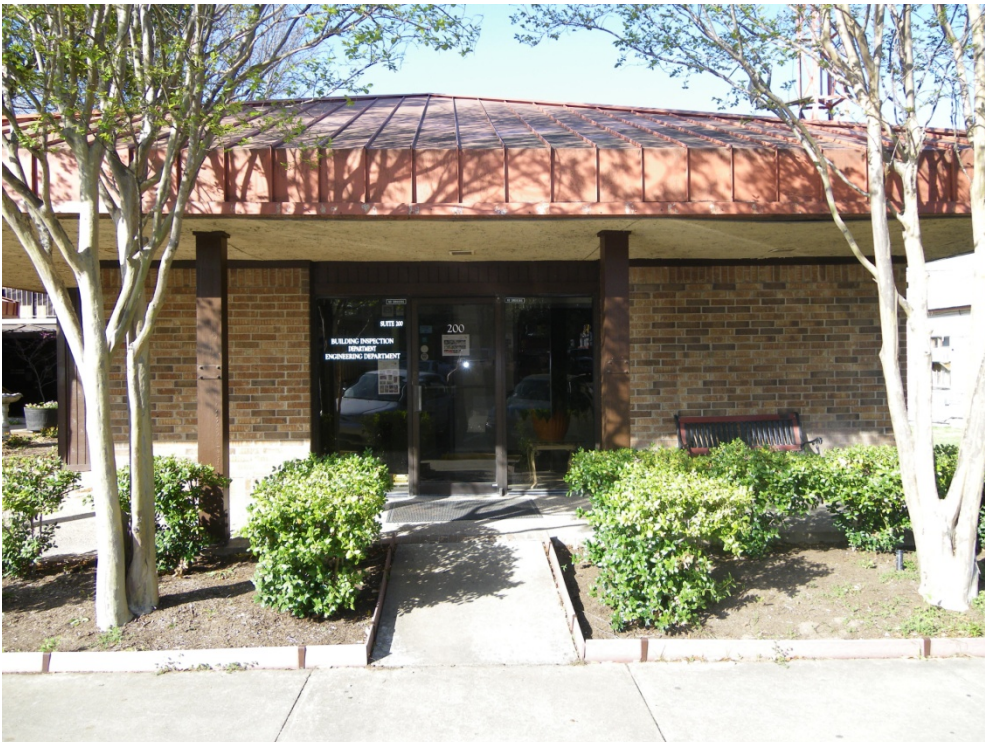
2. Building 200 – Pedestrian pathway

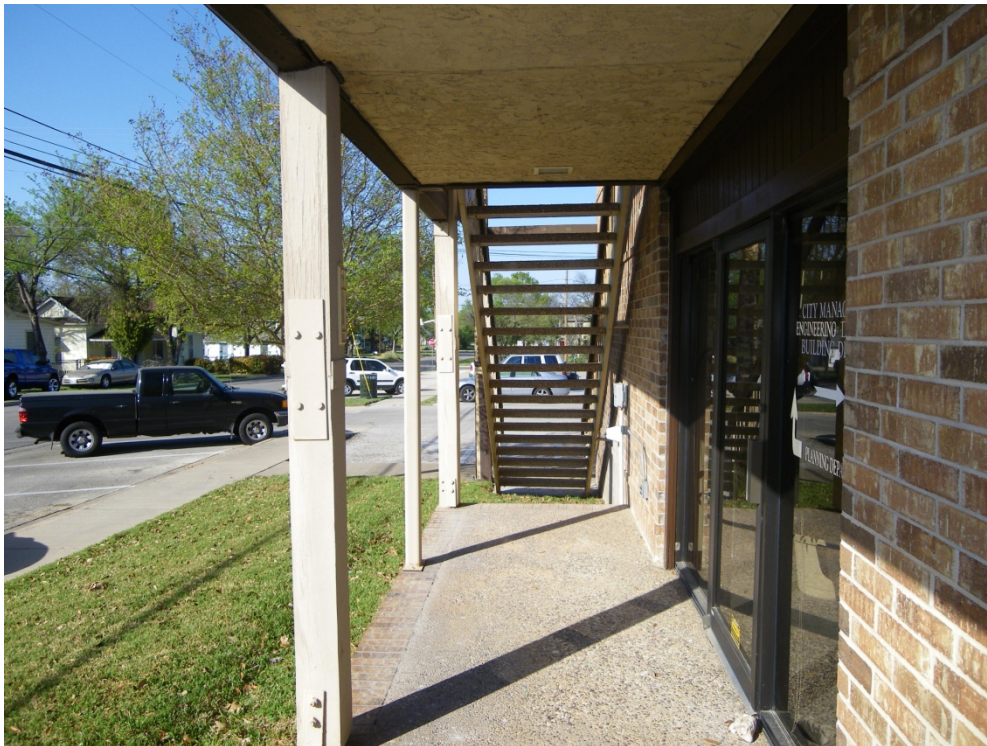
3. West side of Suite 300 –ADA non-compliant protruding object

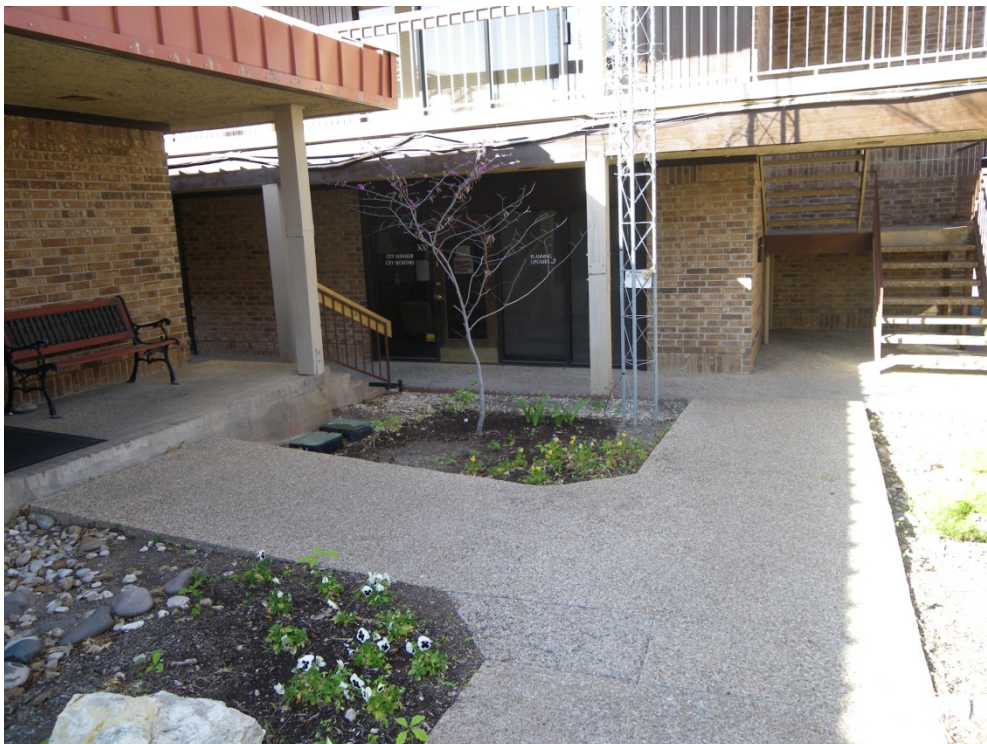
4. Courtyard Area between Buildings: Pedestrian pathway to Suite 300 and location of a proposed elevator for access to Suite 400

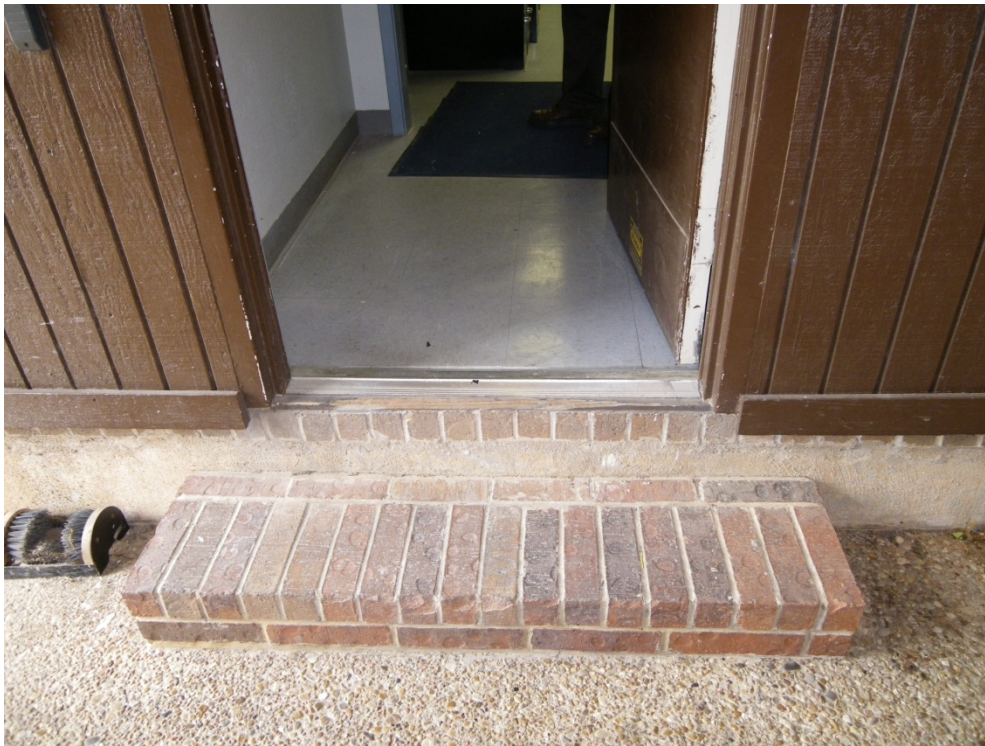
5. Typical ADA non-compliant accessible staff entrance/exit

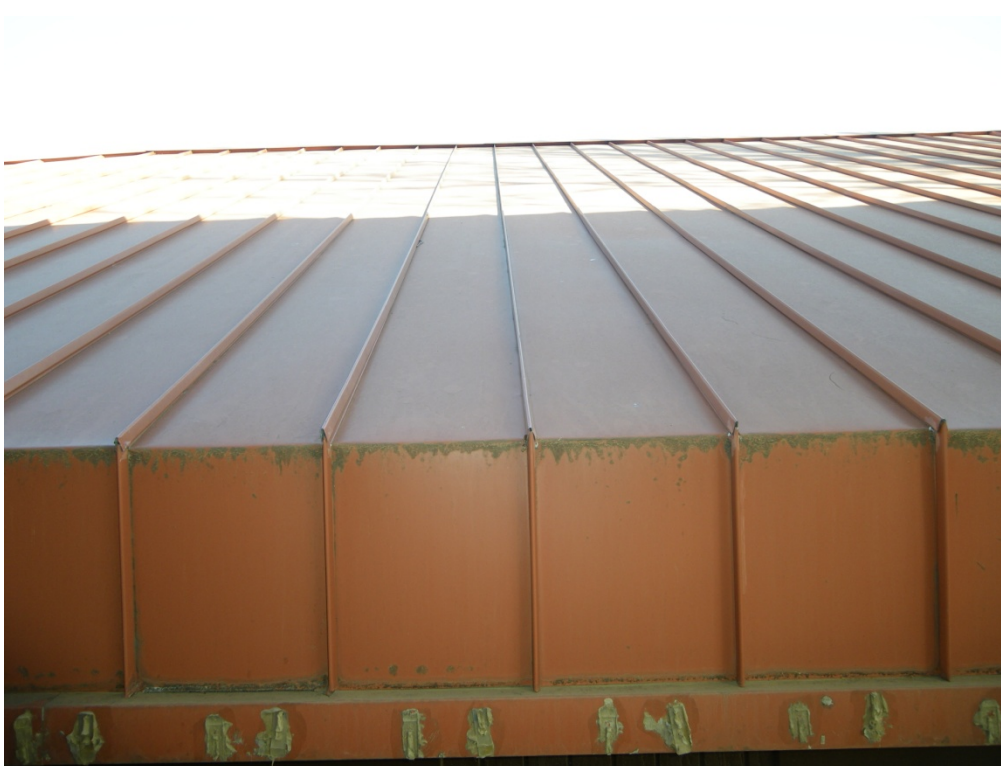
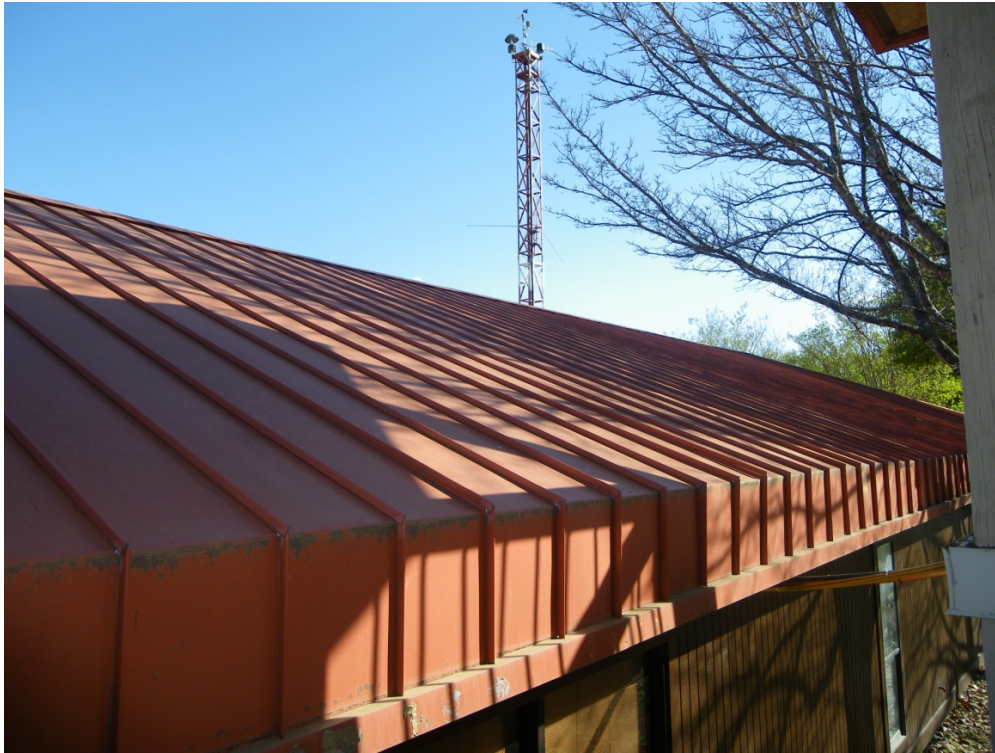
6. Existing standing seam roof – Building 200: Typical conditions observed on all buildings

7. Existing standing seam roof – Building 200: Typical conditions observed on all buildings

<table><tr><td>1. Lease (assume 1 year)</td><td style="text-align: right;">\$122,551</td></tr><tr><td>3. Roof Replacement – Building 100</td><td style="text-align: right;">\$ 40,000</td></tr><tr><td>4. Roof Replacement – Building 200</td><td style="text-align: right;">\$ 55,000</td></tr><tr><td>5. Roof Replacement – Building 300/400</td><td style="text-align: right;">\$ 35,000</td></tr></table>

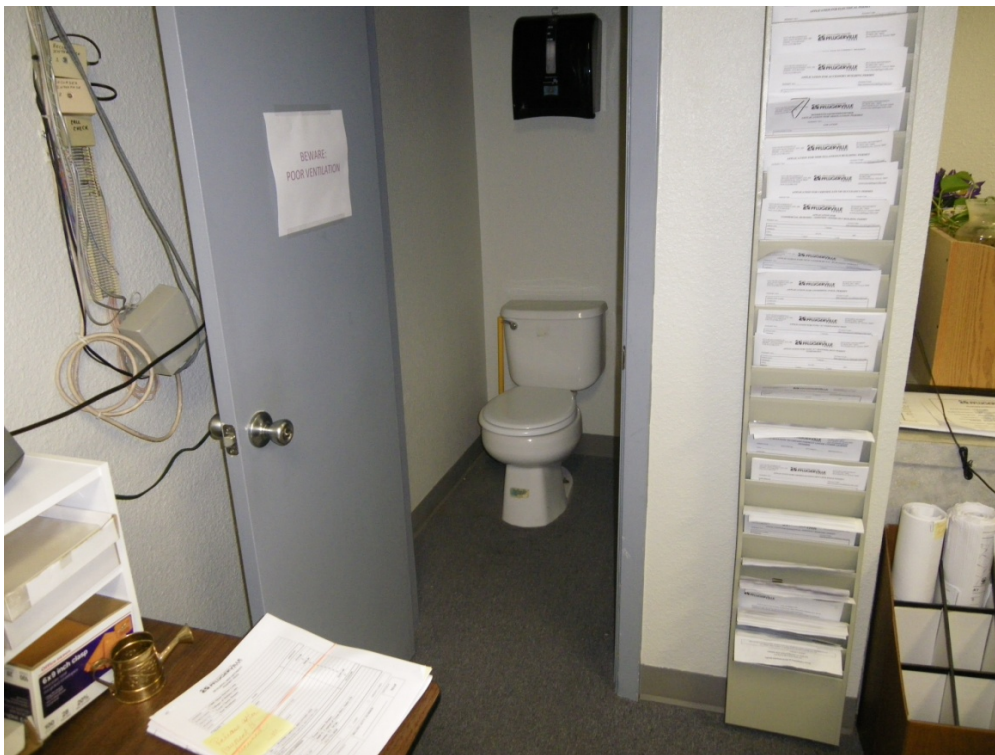
8. ADA non-compliant restroom – Building 200

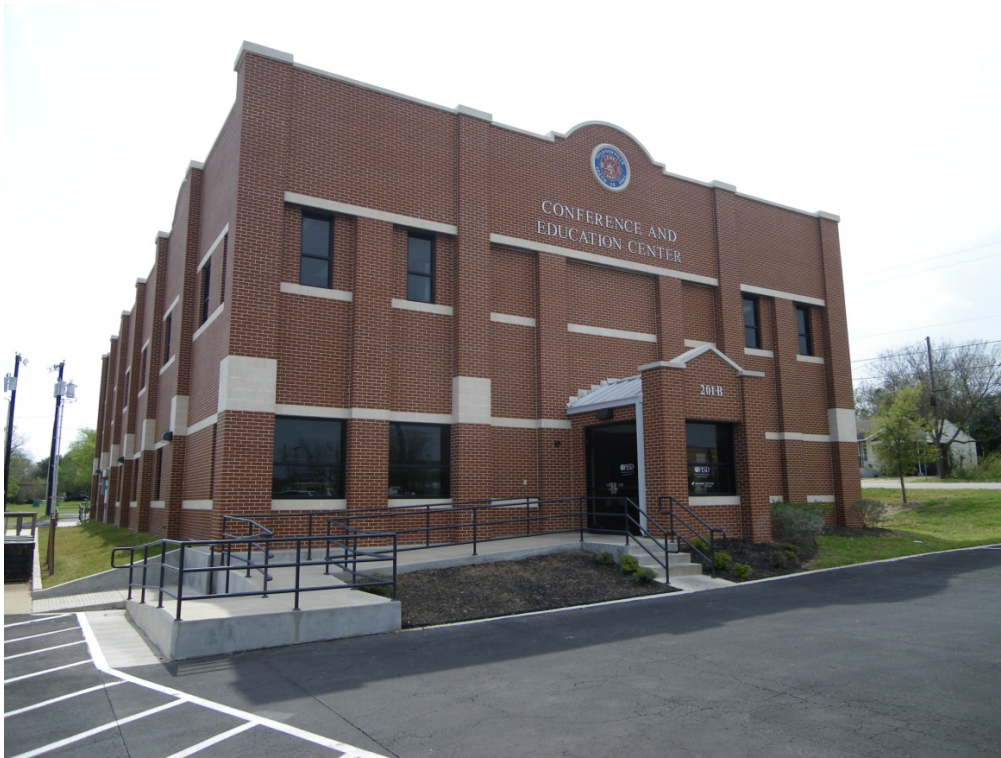
9. Travis County ESD No. 2 – Conference and Education Center

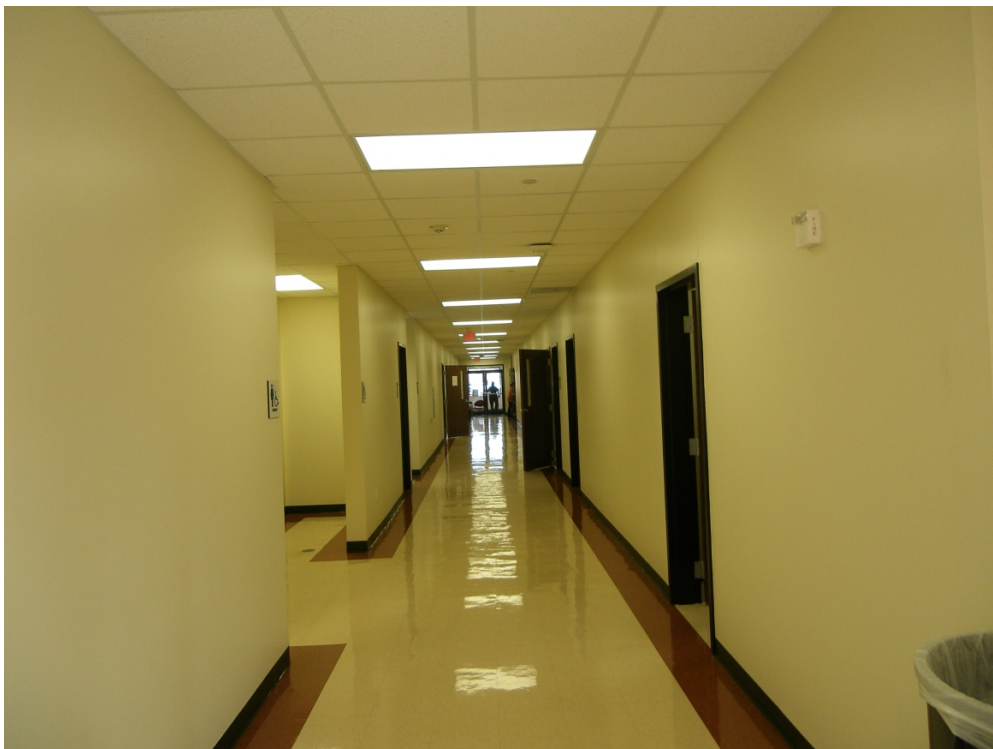
10. Travis County ESD No. 2 – Conference and Education Center – Central Hallway with Suites on both sides

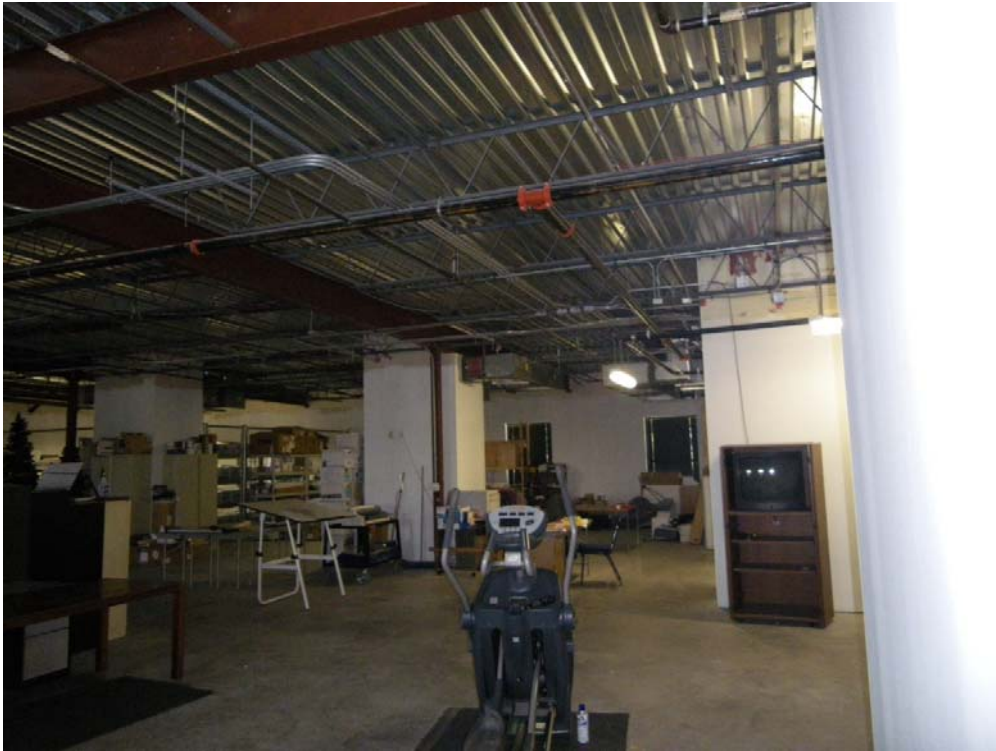
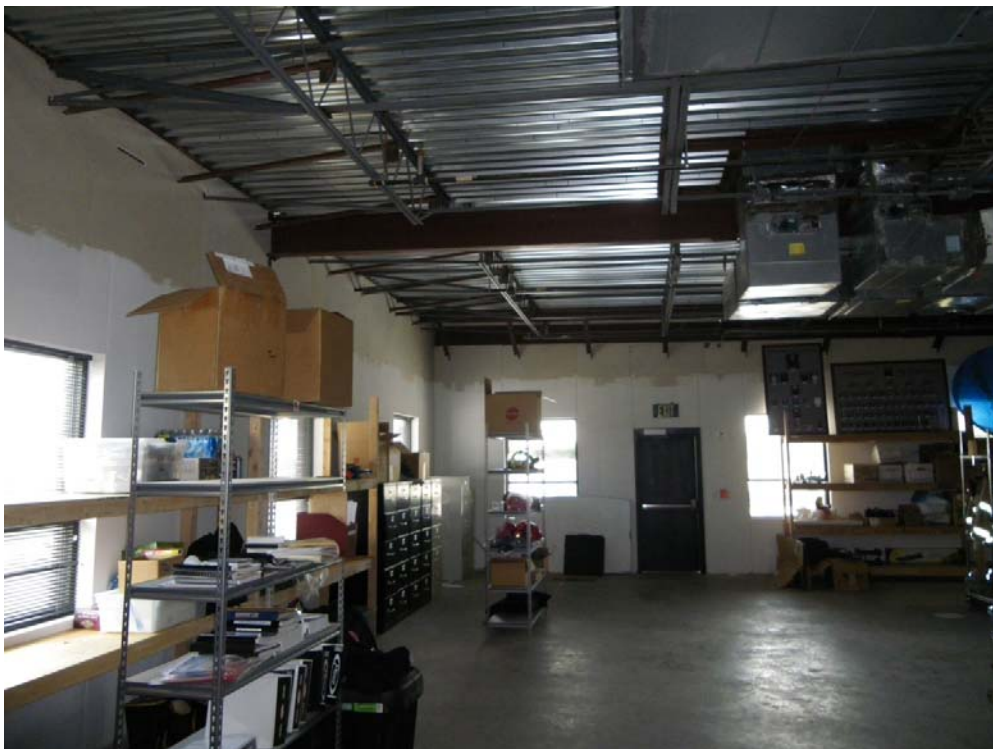
11. Travis County ESD No. 2 – 2nd Floor Facility

12. Travis County ESD No. 2 – 2nd Floor Facility

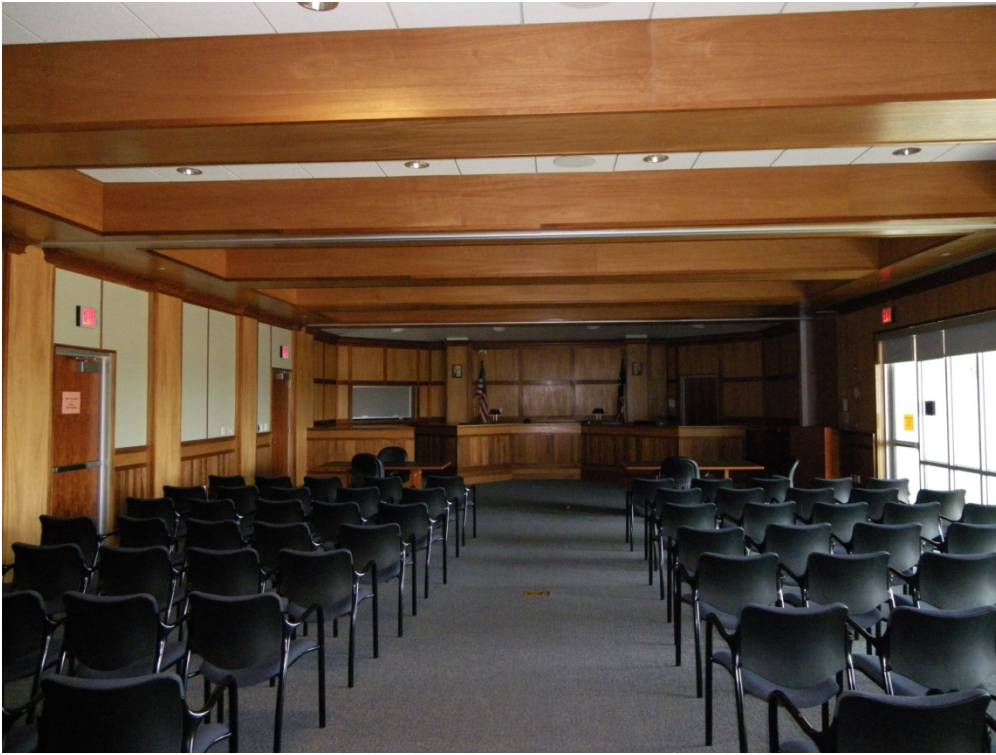
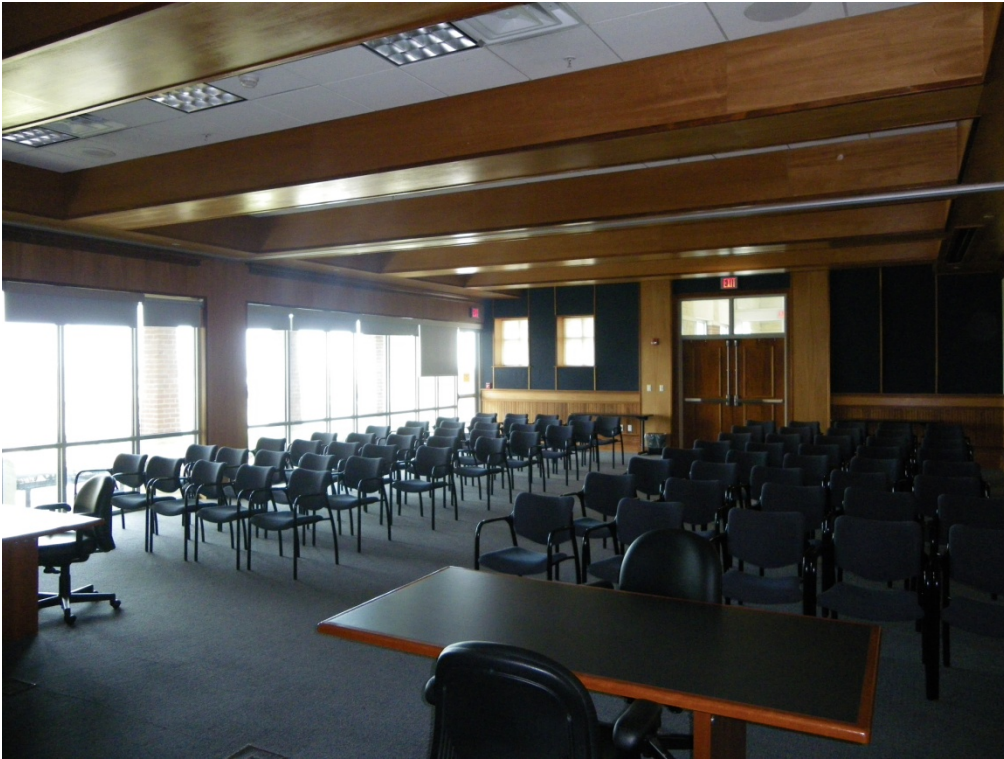
13. Justice Center: Existing Community Courtroom

15. Justice Center: Existing Community Courtroom

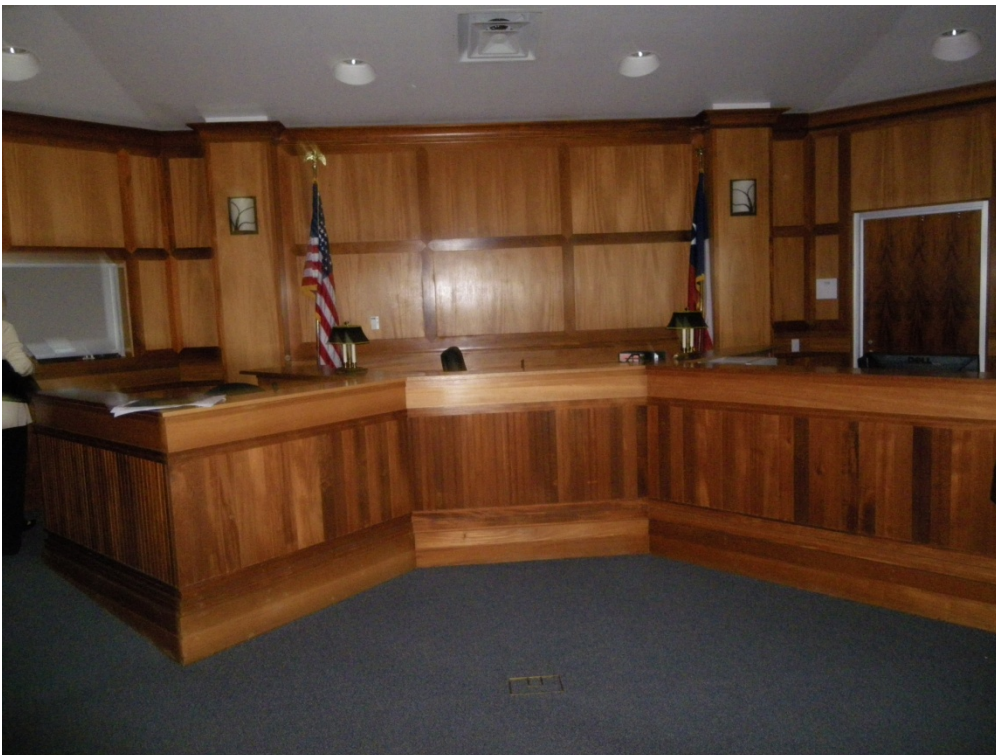
14. Justice Center: Existing Community Court Millwork

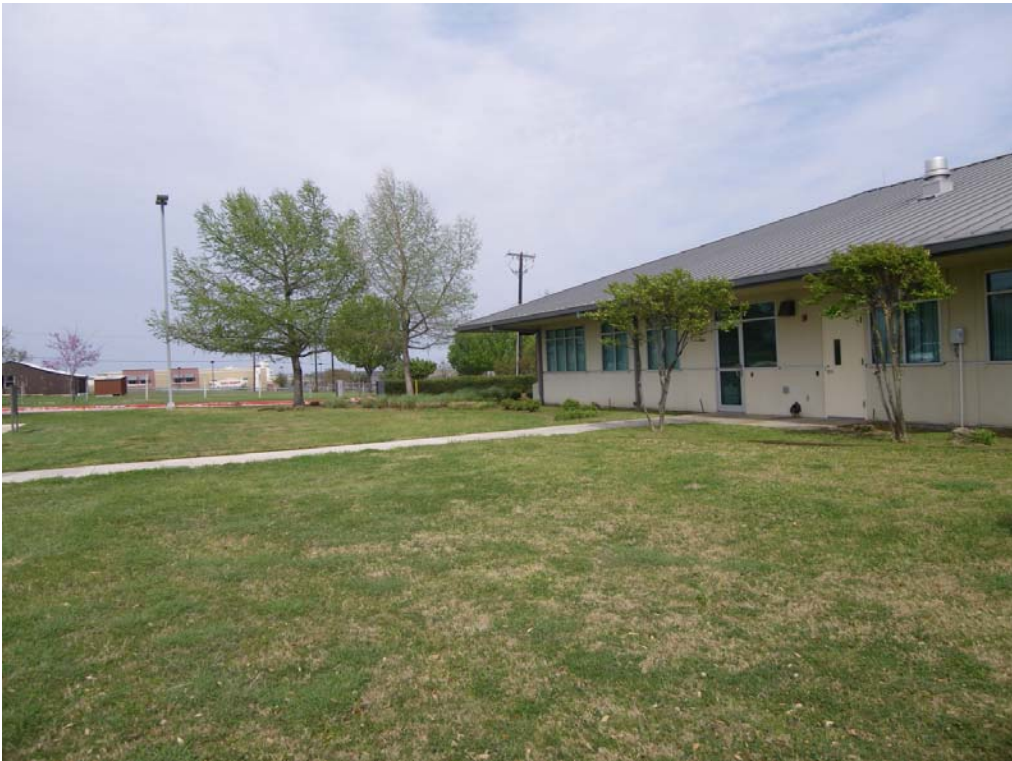
16. Justice Center: Site for proposed expansion to existing facility
