Animal Shelter and Adoption Center

Needs Assessment and Concept Design

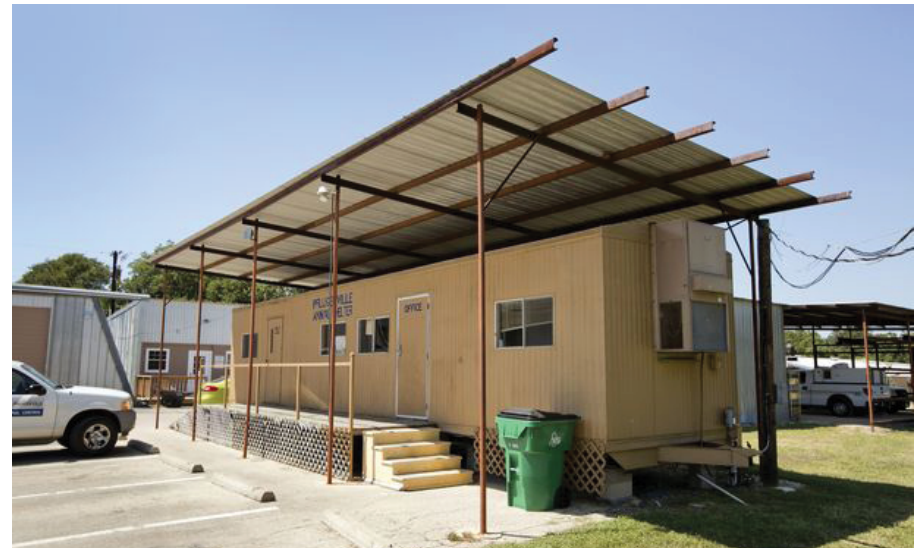
The HVAC system at the dog shelter is insufficient and does not meet current State requirements nor does it maintain industry standards. The adoption side has the boards in place along the gutter, but

every time the wind blows, air blows into the kennels from outside. This makes it difficult to keep the dogs warm in winter (even with the heat running) and cool in the summer. Staff provides blankets or towels for each dog for extra warmth and comfort. During winter, staff often has to plug in space

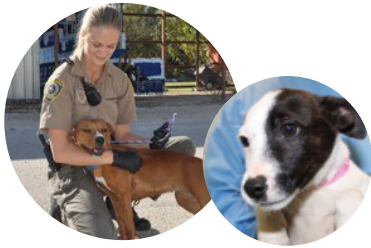
heaters, especially if the temperatures are getting near freezing. Ice has formed along the edge of the kennels by the gutter. If too many heaters are plugged in, the breakers are thrown causing a loss of all heat and sometimes even the lights. The bare metal roof lacks insulation. In summer this causes major cooling issues: it easily heats up and is very difficult to keep cool. Staff runs extra fans on the adoption side, but again, if they run too many, a breaker will be thrown. The units often freeze up causing difficulties in keeping rooms at proper temperatures for animals. If rooms are too cold/

warm, then the animal's health could be at risk for a UTI (Urinary Tract Infection) as well as other infections/diseases. The current HVAC system is not providing adequate air exchange for an animal shelter design. This is apparent as soon as anyone enters the adoptable cat building. There is a strong odor of cat urine which causes visitors to not want to stay an extended time in the room. This has a negative effect on adoption rates.

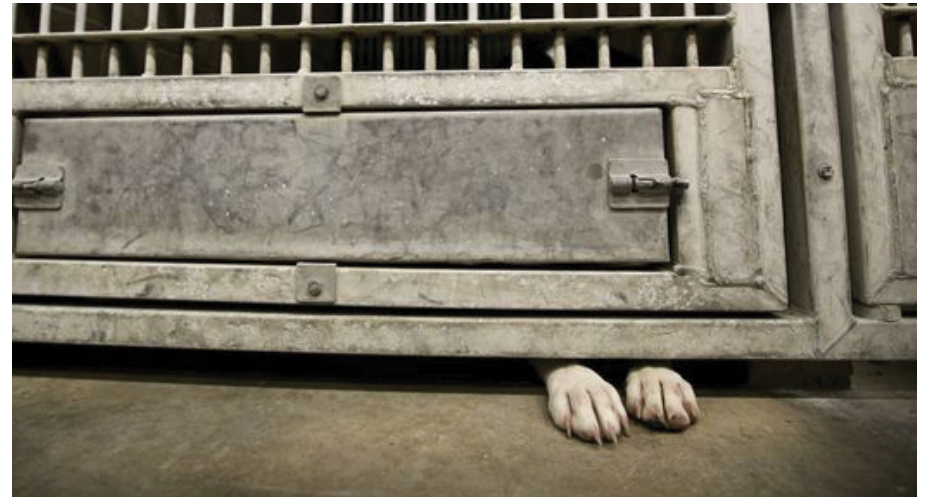
The stray side of the shelter has kennels that are wider and equally as deep as those on the adoption side. Many are larger than what is on the adoption side, but the kennels are only four feet tall and are covered with a wire mesh and chain link tops. Staff has to crouch to enter the kennel with a dog, which is dangerous since it forces them to hover over a dog, which could cause a dog to bite out of

fear. Many dogs jump up and hit their head on the chain link every time they jump. Staff often hits their heads when inside the kennel while trying to scrub the walls and floors. The chain link is damaged on some kennel tops and they have had issues with some dogs escaping the kennel by climbing out the top. Staff, as well as dogs, have been poked in the head with loose wire from damaged mesh or chain link tops. The health department has said these kennels need to be done away with, because they are too short and animals, staff and visitors can become injured. None of the kennels in this facility meet standard safety requirements by the State. They also have swinging gates for the food holders that frequently break and dogs are able to push them open and escape through the opening. The city is unable to replace these kennels with those the health department says are tall enough because the roof slopes too low and the kennels cannot fit. It would require removing the roof and adding height to the walls, then installing a new roof with metal beams instead of wood which would still not help with efficiency in cleaning.
