Subject: 2nd St Demolition Proposal- Tips contract #181101

**SCOPE OF WORK
CITY OF
PFLUGERVILLE
WATER TANK
DEMO
May 12, 2021
TIPS
#181101**

Limited Asbestos Survey Report

Project Address: Well 2 at 2nd Street South ~ Pflugerville, TX 78660

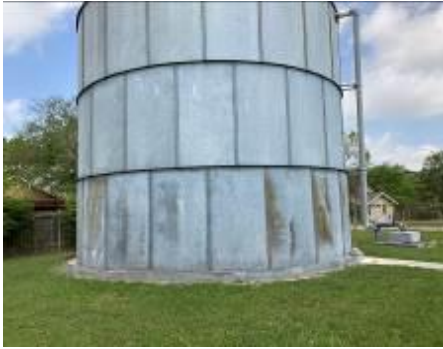
Tank #1

H.A.	Sample No.	Location	Material Description	Estimated SF	% Asbestos
1	1	Tanks 1&2	Black Gasket	300 SF	ND
	2		Black Gasket Brown Compound		ND ND
	3		Black Gasket Brown Compound		ND ND
2	4	Small Building	Black Roofing Shingle with Brown Pebbles	10 SF	ND
	5		Black Roofing Shingle with Brown Pebbles		ND
	6		Black Roofing Shingle with Brown Pebbles		ND
3	7	Large Building	Black Roofing Tar and Felt	100 SF	ND
	8		Black Roofing Tar and Felt		ND
	9		Black Roofing Tar and Felt		ND

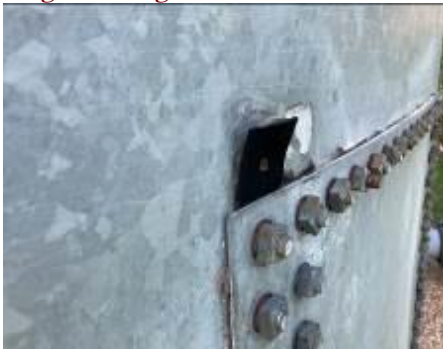
Sample 1-3

Sample Layers	Asbestos Content
Black Gasket	ND
Sample Composite Homogeneity:	Good

Sample Layers	Asbestos Content
Black Gasket	ND
Brown Compound	ND
Sample Composite Homogeneity:	Moderate

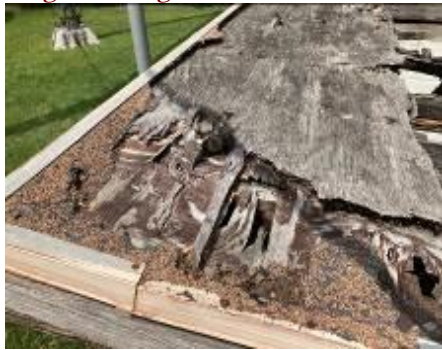
Sample 4-6

Sample Layers	Asbestos Content
Black Roofing Shingle with Brown Pebbles	ND
Composite Non-Asbestos Content:	20% Glass Fibers
Sample Composite Homogeneity:	Good

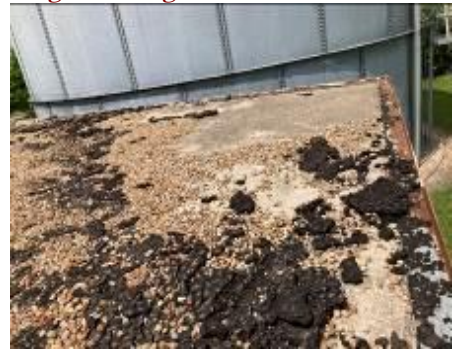
Sample 7-9

Sample Layers	Asbestos Content
Black Roofing Tar and Felt	ND
Composite Non-Asbestos Content:	5% Cellulose
Sample Composite Homogeneity:	Moderate
